Benthall Edge Woods SSSI

Patten's Rock, the Quarry and Bower Yard Kilns

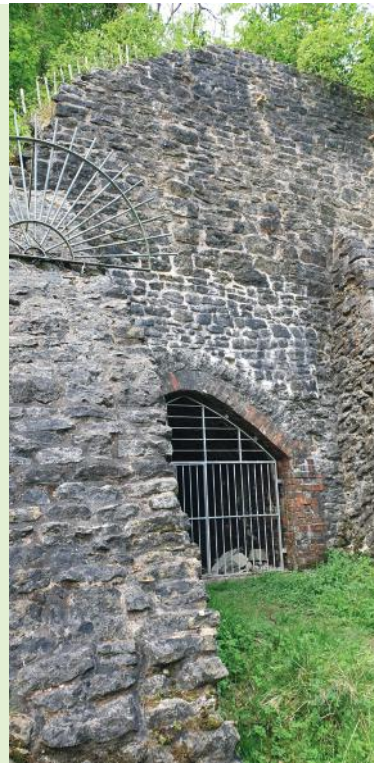
The lime kilns were originally built during the mid 1800s and operated until the 1870s, after which they fell into disrepair. A date of '1928' is inscribed above the kiln arch, indicating a date when this kiln was repaired and put into production again in the 1930s.

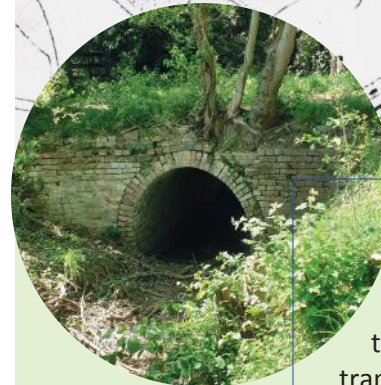
Old tramway bridge
Spout Lane
bridleway
(red arrow on map)

The coming of the Severn Valley railway involved building an embankment: two kilns had to be demolished and tramways and tracks bringing lime to the Severn diverted under a railway bridge. A substantial retaining wall was needed at the river port edge. A brick bridge was built to take a tramway over the railway line. The railway opened in 1862 but proved to be the downfall of the local lime industry. A national rail network made small local kilns unprofitable compared to large industrial plants elsewhere. In 1866 Patten gave up the quarry and kilns and they fell into ruins, though there was a brief short lived revival in the 1930s.

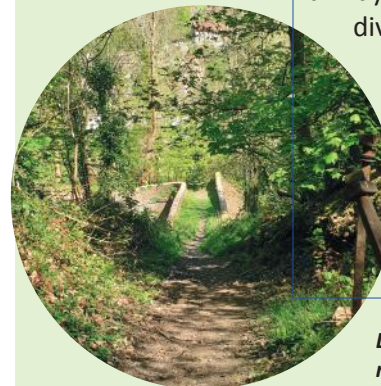
Left: Tramway over
1860s
railway near
Bower Yard
